CASE STUDY

A Trenchless Rehabilitation Milestone – Fusible PVC Slipling in Peoria

Sliplined Fusible PVC force main to provide a long-term solution in the water reclamation process for the city of Peoria.

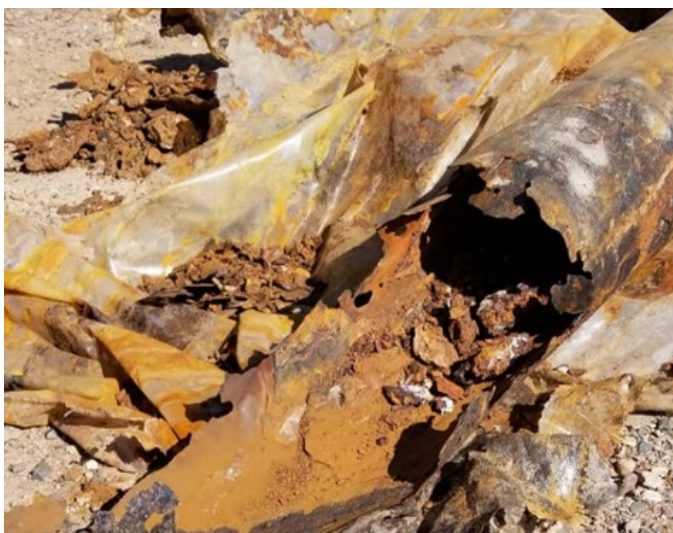
DIP sewer force mains have a higher probability of corrosion due to entrapped air in the pipeline. The entrapped air leads to oxidation of hydrogen-sulfide (H₂S) gas into sulfuric acid, which deteriorates the cement liner and leads to corrosion of the ductile iron.

Based on the visual observations, field measurements, and testing of the excavated sections, Dibble discovered corrosion of the force main and serious deterioration, indicating the need for rehabilitation or replacement. This force main is the only mechanism for disposal of the WAS from the BWRF, making it imperative that the pipe remain in service.

Section of Severely Corroded Pipe

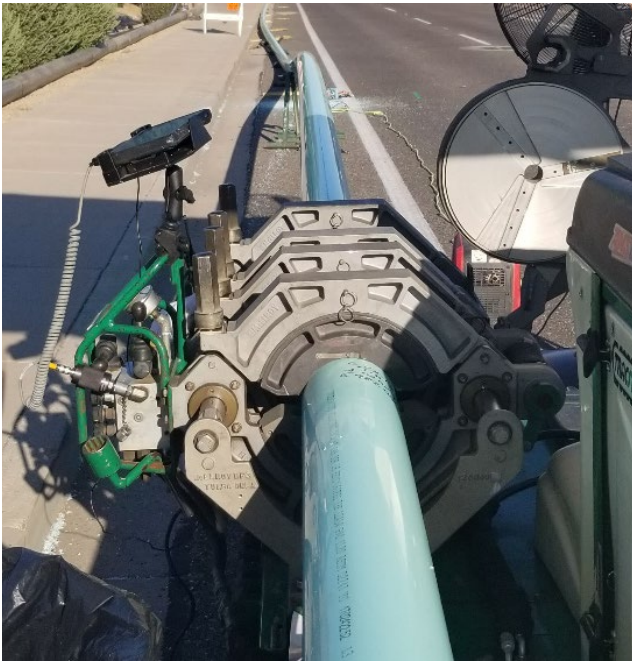
Installation Process
