CASE STUDY

Levee System Inspection

Levee Systems Project Summary	
Project:	Levee Pipe Assessments
Location:	Scottsdale/Tempe/Phoenix, Arizona
Owner:	Flood Control District of Maricopa County
Engineer:	Dibble
Delivery Method:	Job-Order-Contract (JOC)
Market:	Civic

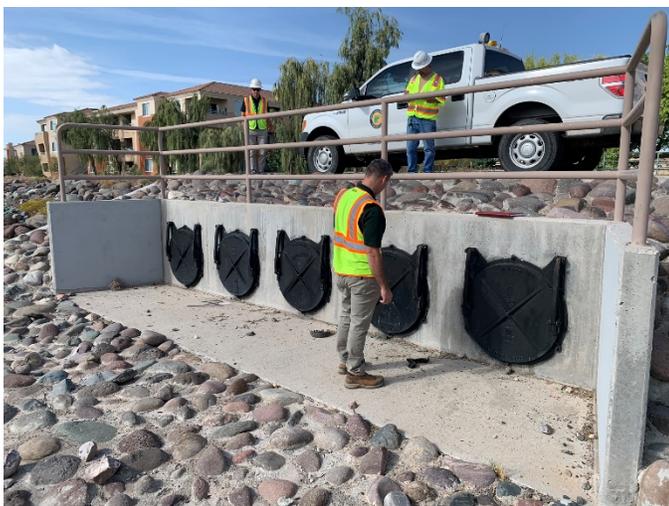
Five, 30-inch RCP Outlets

The Skunk Creek, Part 1 assessment observed minor defects in the five, 30-inch RCP inlets, concluding with no immediate rehabilitation action needed. The team observed more severe defects in the 24-inch RCP that warranted a recommended rehabilitation method of lining the existing pipe with CIPP. Dibble recommended the repair be done within a year of the assessment results to preclude further damage and possible risk of failure.

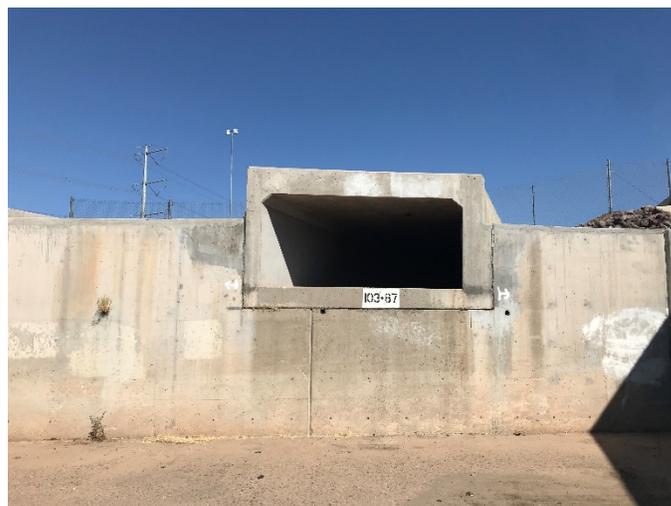
Concrete Box Culvert Outlet

Skunk creek, Part 2 assessment results consisted of multiple structural defects throughout both the RCP and the CBC. Defects included cracking in the ceiling, walls and floor; efflorescence at the joints and cracks; rust staining around joints and cracks; deteriorated joint material and in adjacent concrete to the joints; and water leaks through the ceiling joints and cracks. The structural engineer provided recommendations for general structural repair, based on the assessment reported, to the FCDMC. The CBC and RCP segment joints that have defects,

as well as all cracks, should be repaired prior to the next required inspection of five years. Prior to these repairs, it is recommended that any efflorescence build-up, dirt, or debris in the joints or cracks be removed.
