CASE STUDY

Tempe Bell Butte Water Storage Tank Rehabilitation

Written By: Jesse Udall, PE | Susanna Mabery

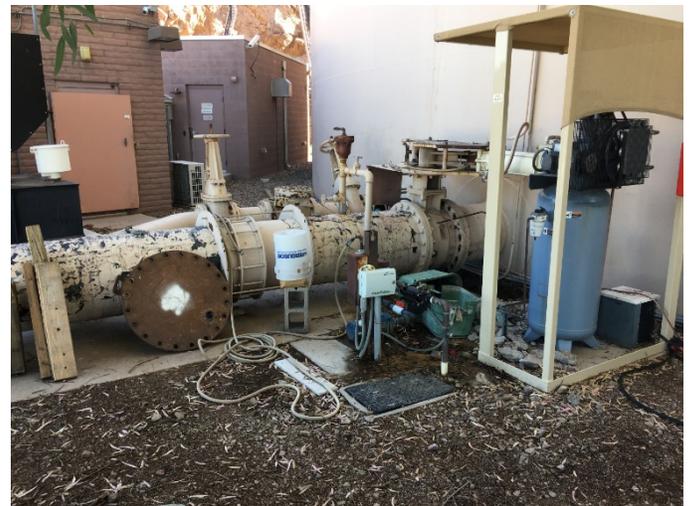
Preservation of water tanks, through routine inspection and maintenance, is necessary to avoid unexpected failure and potential costly repairs. In 2012 the tanks underwent a routine asset preservation assessment that identified various improvements that needed to be made. The 2012 assessment observed that all piping and valves appeared to be original to the tank installation and had reached their service life.

Mechanical Piping Prior to Rehabilitation

All above grade mechanical piping and valving was replaced with modern pipe and valves meeting current AWWA and ANSI standards.

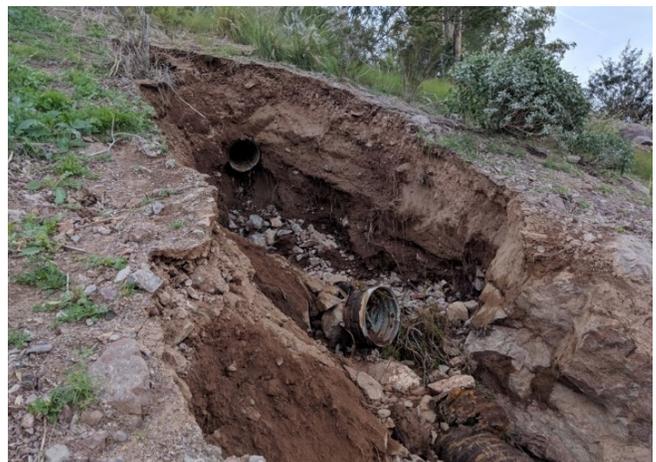
During the second dewatering, the CMP experienced a major failure. Due to the butte's steep slopes, this failure caused a portion of the butte to slough down and block the access road, exposing a section of the existing pipe, and revealing a pipe full of holes from corrosion. This failure created an unexpected challenge to the rehabilitation process.

CMP and Butte Failure

The failure of the drainpipe during the dewatering process resulted in the need to add the rehabilitation of this pipeline to the project tasks. Collaboration between the City, PCL, and Dibble on a cost-effective, long-term repair became a top priority, and several possible solutions were considered. The existing drainpipe was repaired and lined with a Cured In-Place Pipe (CIPP) method by the subcontractor NuFlow, a company specializing in trenchless pipe repair. The butte

slope was also restored and stabilized. SRPMIC representatives assisted in all aesthetic and culturally sensitive decisions regarding the site and its repairs. The shotcrete used to reinforce the slope was tinted to an SRPMIC approved color to blend with the surrounding environment.

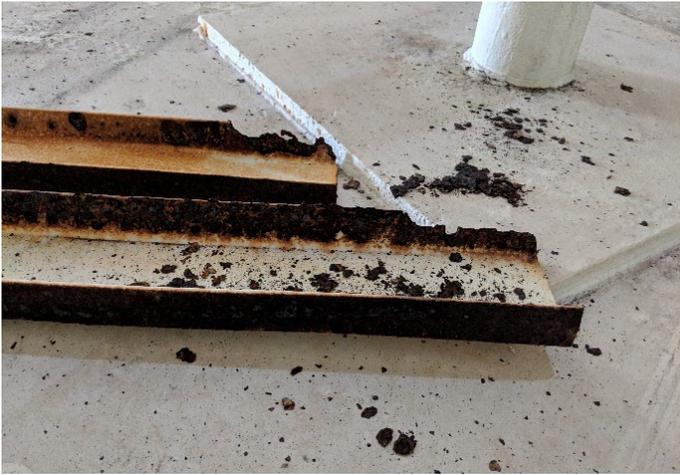
The structural rehabilitation of the tank covered several items discovered during the initial assessment. Once PCL and MMI, a subcontractor with expertise in tank and industrial services, entered the tank to begin work, they discovered corrosion of the roof framing system to be more extensive than originally anticipated. The team took measures to correct the deficiencies, including replacing all roof rafters and one girder, and replacing the bent steel plate connections with properly designed plates. To provide the rafters with additional lateral stability, the contractor installed midspan, lateral bracing for all inner radial rafters. All steel beams that exhibited weak axis bending or buckling were replaced with equivalent sections. Steel floor plates showing more than 25 percent section loss were patched with a 1/4-inch thick steel plate with a fillet weld.

Severe Corrosion on Roof Rafters

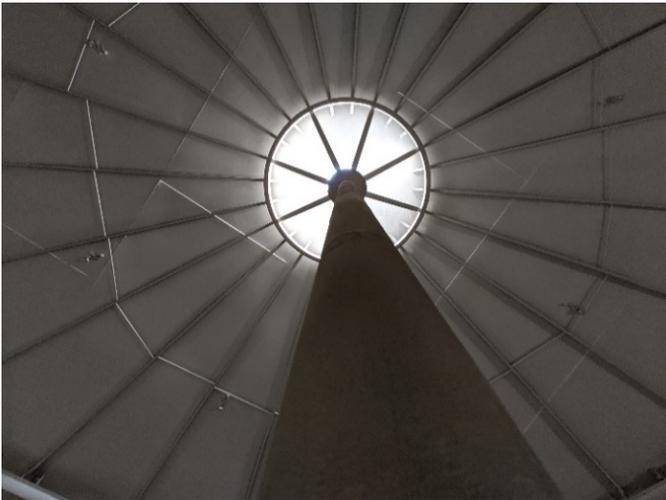
Halo Structure

During construction, MMI observed a severely corroded dollar plate that would require replacement. An innovative design option presented by MMI was to use a halo support structure to replace the damaged dollar plate. The halo structure is advantageous to the design as it improves the air flow in the tank and reduces the surface area for potential corrosion. It also provides another access point for inspection.

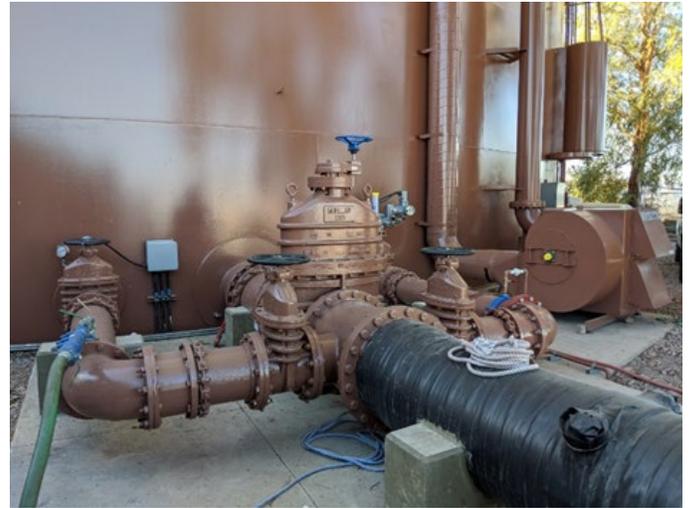
New Mechanical Piping

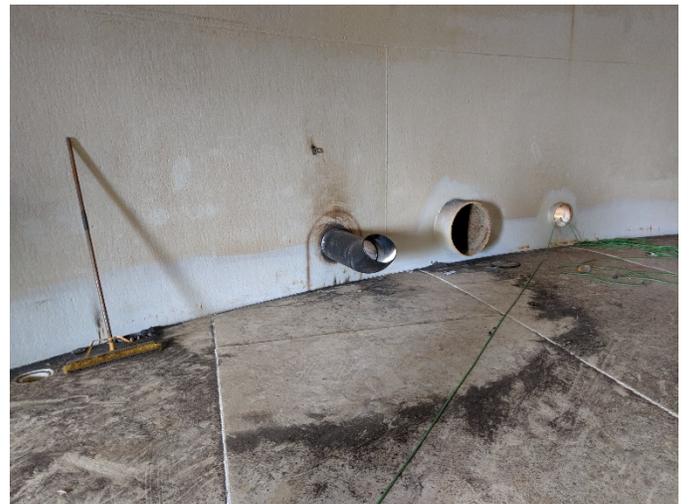
New 12-inch Inlet Pipe

A new dedicated 12-inch inlet was integrated into the design. The inlet pipe provides several advantages to the tank: first it is angled upward, creating an increased flow velocity to mitigate

stratification of the water and second to improve water mixing in the tank.
