CASE STUDY

Storm Drain Investigation

Uncovering an unknown underground asset through confined space manned entry.

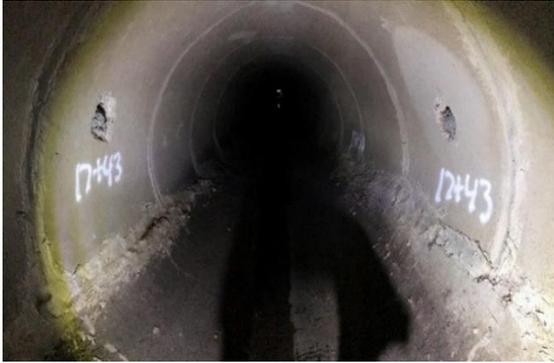
Storm drain with reference stations and inlet pipes

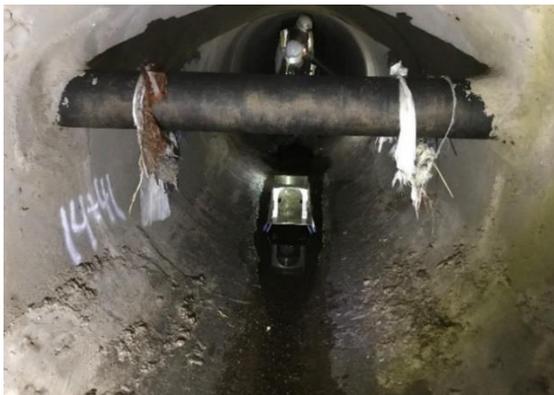
The structural team did not discover a significant number of deficiencies within the pipeline. However, the storm drain revealed many interesting conditions; for example, the team found multiple protruding pipes into the storm drain, as well as a few sewer laterals running through. The structural assessment documented the location of these sewers to allow the City to track for future rehabilitation or maintenance efforts.

Sewer lateral spanning storm drain
