CASE STUDY

Jacaranda Parkway

Using CIPP to rehabilitate a 27-inch residential sewer pipeline.

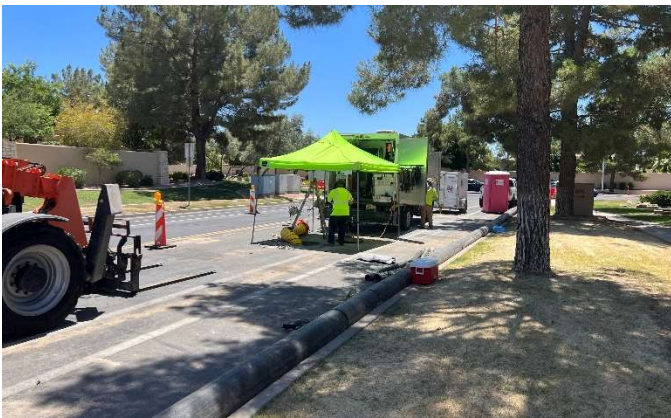
The project required construction of an extremely long (approximately 4,000-foot) sewer bypass that operated continuously to maintain uninterrupted sewer services for about 2 months during the rehabilitation. The above-ground sewer bypass ran on the street, as well as in the landscaped areas off road in certain segments.

Sewer bypass along Jacaranda Parkway

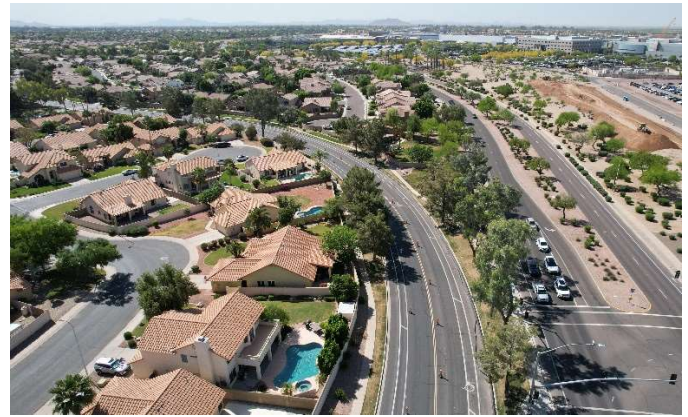
Because Jacaranda Parkway is a radius street (i.e., it follows a curve), the existing RCP follows the curvature of the road. The Jacaranda Parkway segment is approximately 3,000 feet with 13 manholes. To accelerate the construction schedule and reduce the disturbance time to the surrounding neighborhood, the CIPP installation “shots” (the distance from manhole to manhole) were extended significantly longer than average. In some cases, the shots measured up to 1,100–1,200 feet rather than the typical 400–500 feet from manhole to manhole.

Jacaranda Parkway is a radius (curved) street

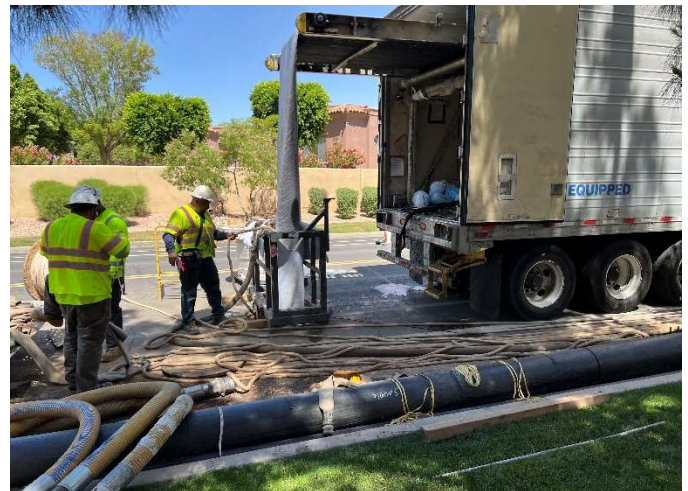
Installation of the CIPP liner

Due to the significant length of the shots, the team decided to use hot water rather than the conventional steam method to cure the liner. The hot water method required approximately 35 hours to cure, rather than the typical 5 hours necessary for steam cure. The manholes along the road were used to access the sewer line. A 4-inch hose was hooked up to a boiler to provide constant hot water circulating through the CIPP liner during the curing process. After curing, the liner was cooled down very slowly to minimize shrinkage.

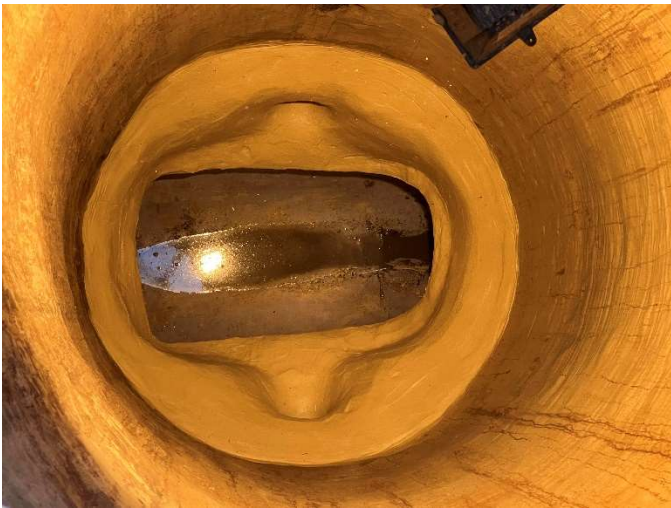
Manhole rehabilitation work was completed on 13 manholes

Manhole rehabilitation work included coating the bench and channel of 13 manholes. The bench (above the sewer line) is the very bottom of the manhole that connects to a channel, while the channel (at the sewer line) connects the pipes from one space to the next.
