CASE STUDY

Tempe Bell Butte Water Storage Tank Rehabilitation

Written By: Jesse Udall, PE | Susanna Mabery

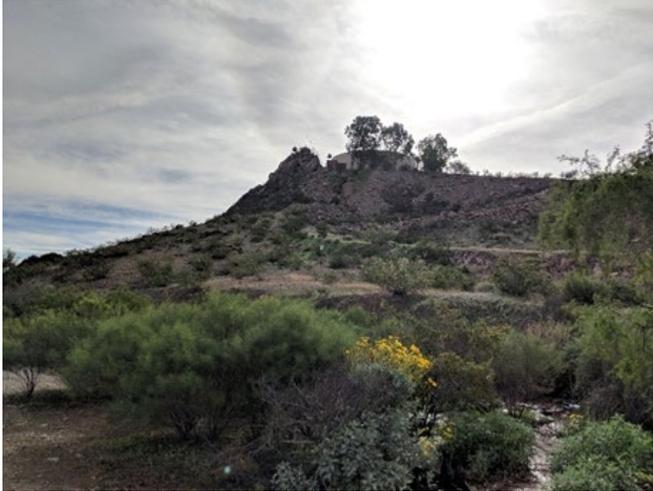
View of the Bell Butte Water Storage Tank from Below

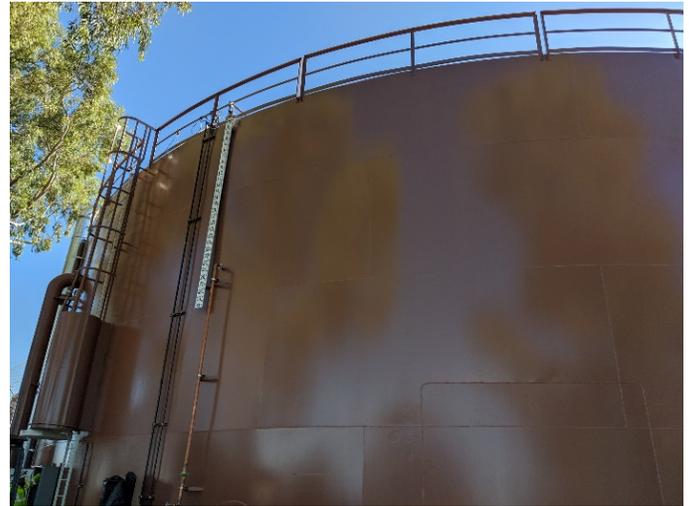
Exterior View of Tank after Recoating

For the final touches on the tank interior, PCL’s team cleaned all existing paint and surface corrosion with an abrasive media, through blasting, and then recoated. All bolts, nuts, and washers were eliminated, and connections were seal welded and coated along with the rest of the interior of the tank.

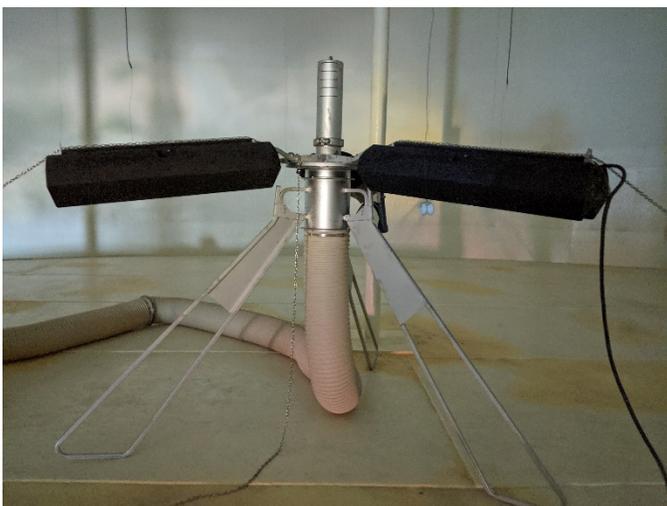
THM Removal Aerator

The City monitors levels of Trihalomethanes (THM's) in the water and asked Dibble to design a system that would reduce THM levels. THM's are a family of chemical compound by-products that are formed during the disinfection process when chlorine is combined with naturally occurring organic and inorganic matter in water. The Environmental Protection Agency (EPA) has established allowable limits for THM's, as high levels can potentially cause health issues. A process to address the THM levels was included in the rehabilitation plan.
